**LETTER REPORT
FOR
FORRESTVILLE AVENUE MERCURY SPILL
CHICAGO, COOK COUNTY, ILLINOIS
TDD: S05-0006-001
PAN: 0N0101RZXX**

July 10, 2000

Re: Forrestville Avenue Mercury Spill
Chicago, Cook County, Illinois
TDD: S05-0006-001
PAN: 0N0101RZXX

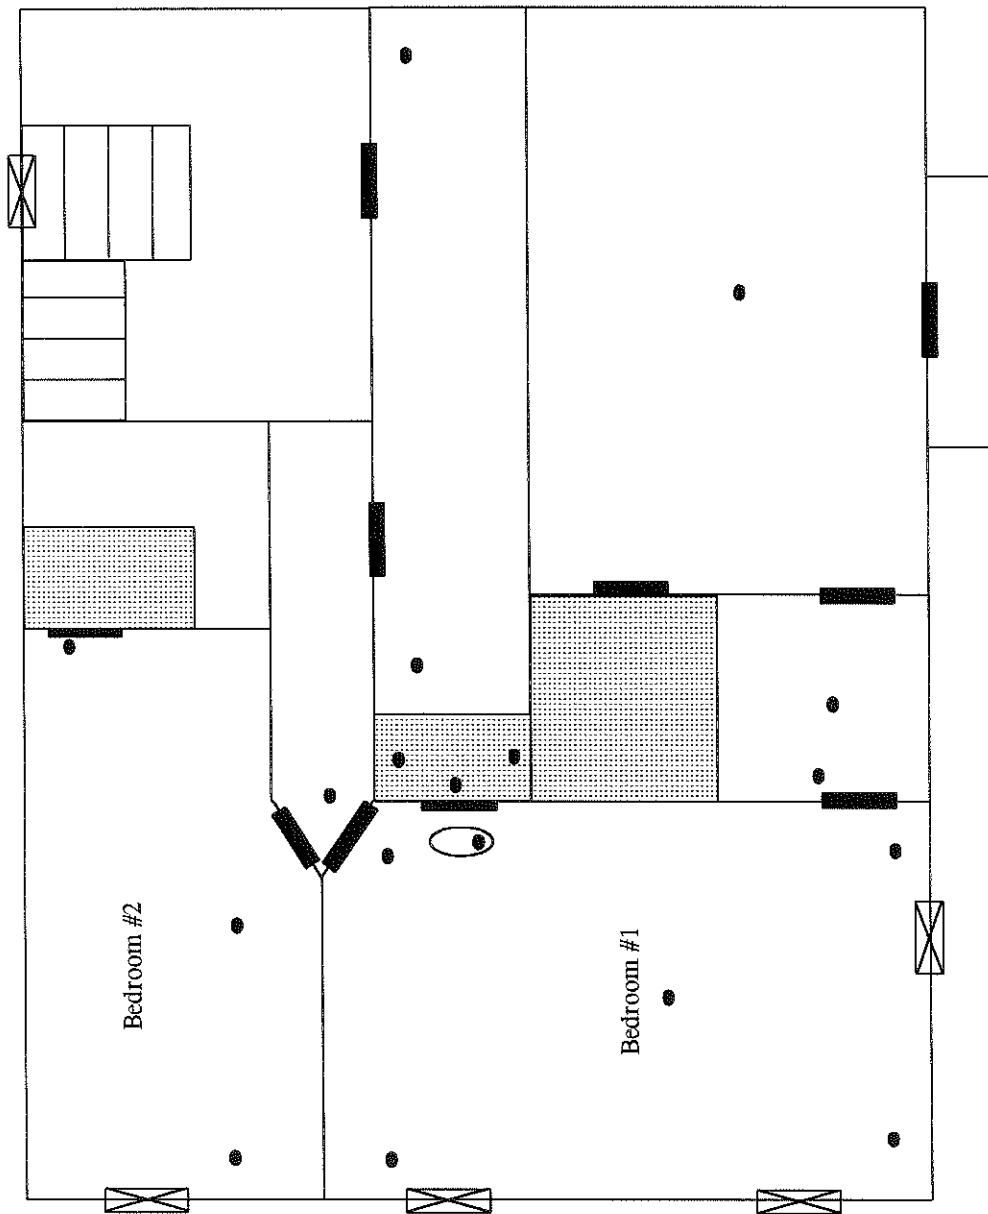
Title	Air Monitoring Location Map	Figure	3
Site	Forrestville Avenue Mercury Spill	Scale	Not to scale
City	Chicago	State	Illinois
Source	Ecology and Environment, Inc.	TDD	S05-0006-001
		Date	July 2000

Time	Reading	Location
1345	0.009	Entrance/northeast corner of bedroom #1 (before spill area uncovered).
	0.014	Southeast corner of bedroom #1 (before spill area uncovered).

0.014	Southwest corner of bedroom #1 (before spill area uncovered).
	0.010	Northwest corner of bedroom #1 (before spill area uncovered).
	0.109	Garbage bag above spill location (before spill area uncovered).

0.889	Spill area (floor level).
1355	0.044	Entrance/northeast corner of bedroom #1 (after spill area uncovered).
	0.024	Southeast corner of bedroom #1 (after spill area uncovered).

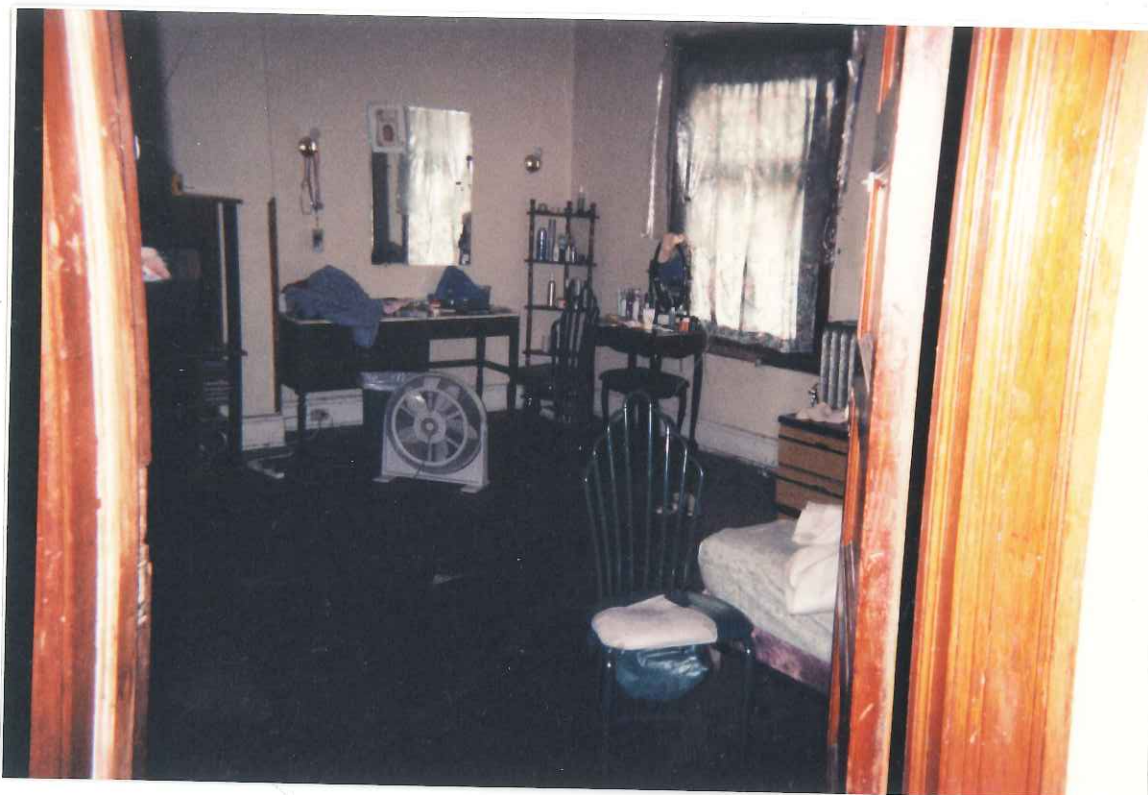
Site: Forrestville Ave. Mercury **Date:** June 1, 2000 **Time:** 1340
Location: Chicago, IL **Direction:** Southwest **Photographer:** K. Theisen (U.S. EPA)
Subject: Bedroom #1/spill location.

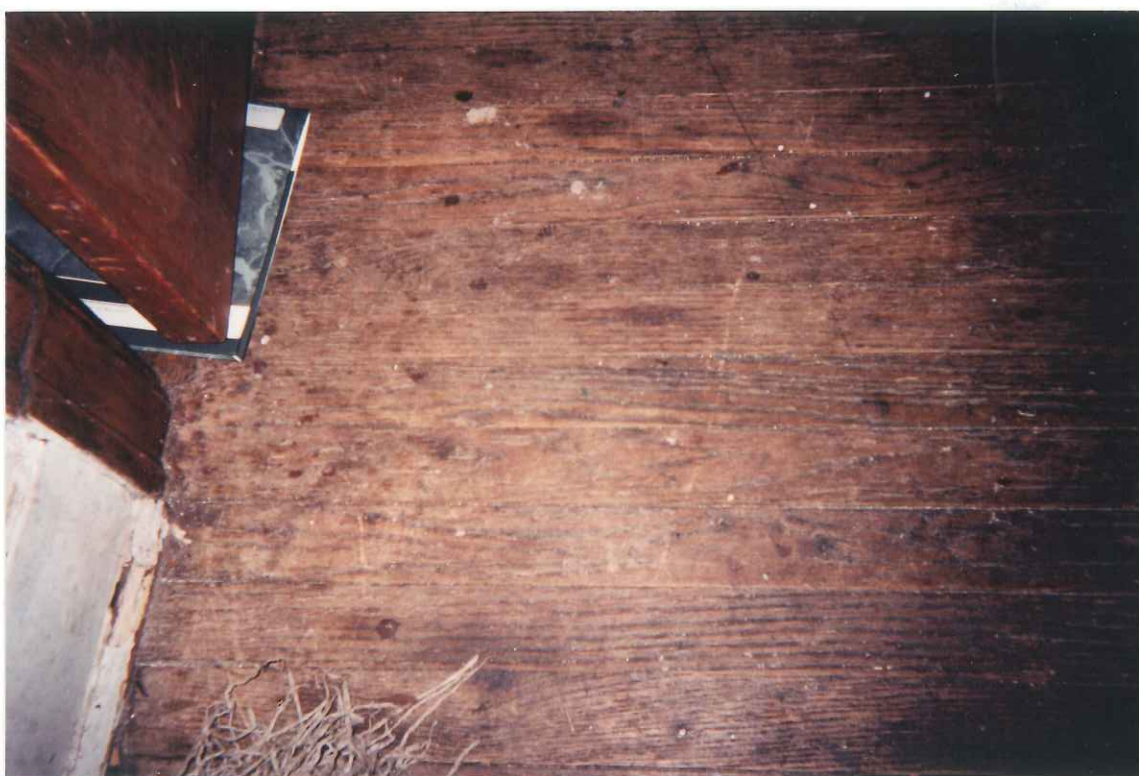
Site: Forrestville Ave. Mercury **Date:** June 1, 2000 **Time:** 1342
Location: Chicago, IL **Direction:** Down **Photographer:** K. Theisen (U.S. EPA)
Subject: Spill location with mercury droplets between floorboards.

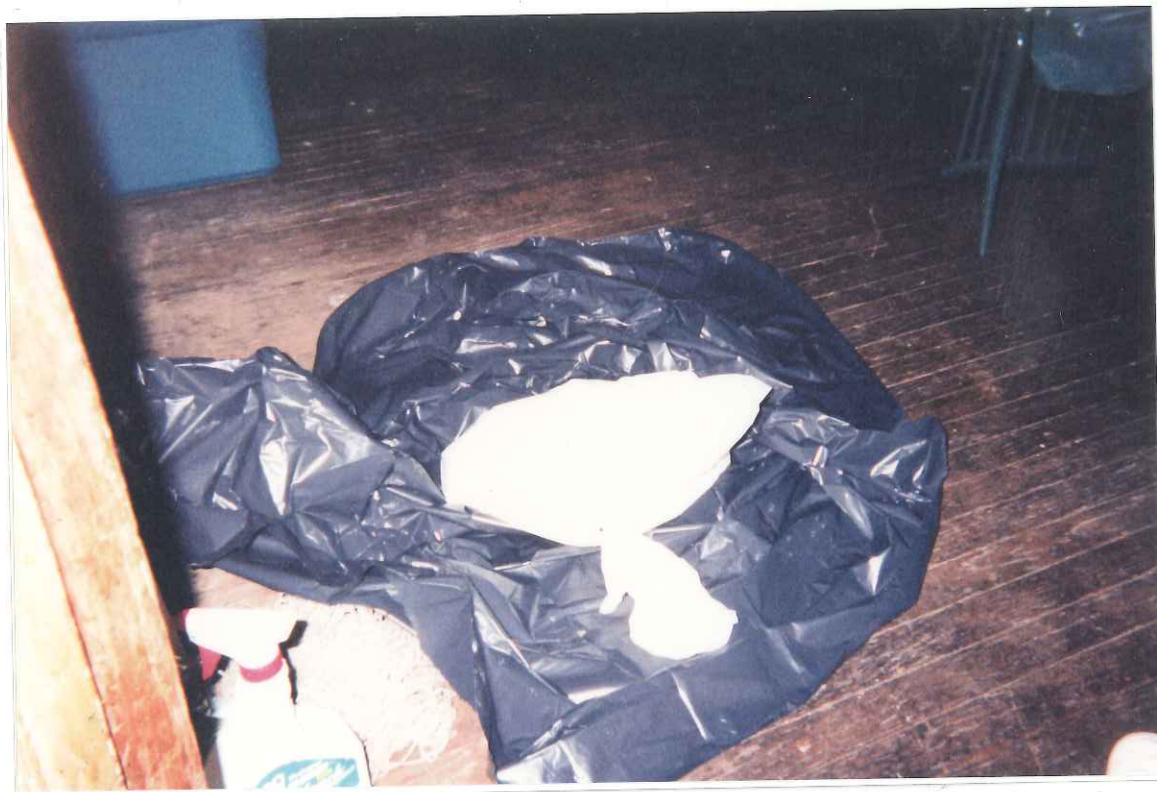
Site: Forrestville Ave. Mercury **Date:** June 1, 2000 **Time:** 1345
Location: Chicago, IL **Direction:** Down **Photographer:** K. Theisen (U.S. EPA)
Subject: Bagged broken blood pressure cuff atop garbage bags covering spill area.

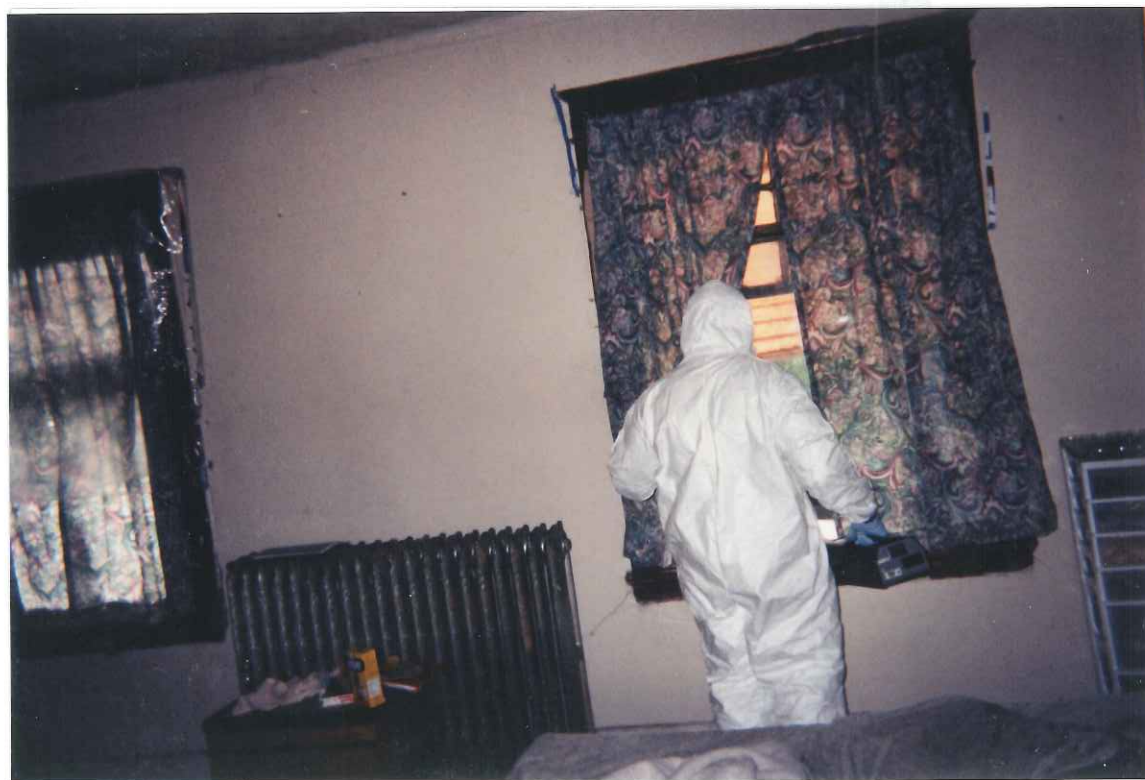
Site: Forrestville Ave. Mercury **Date:** June 1, 2000 **Time:** 1352
Location: Chicago, IL **Direction:** West **Photographer:** K. Theisen (U.S. EPA)
Subject: START monitoring for mercury vapors in bedroom #1.
